## **2016 Operations, Maintenance, and Monitoring Report**

**West Belle Pass Headland Restoration  
(TE-23)**

State Project Number TE-23  
Priority Project List 2

June 2016  
Lafourche Parish

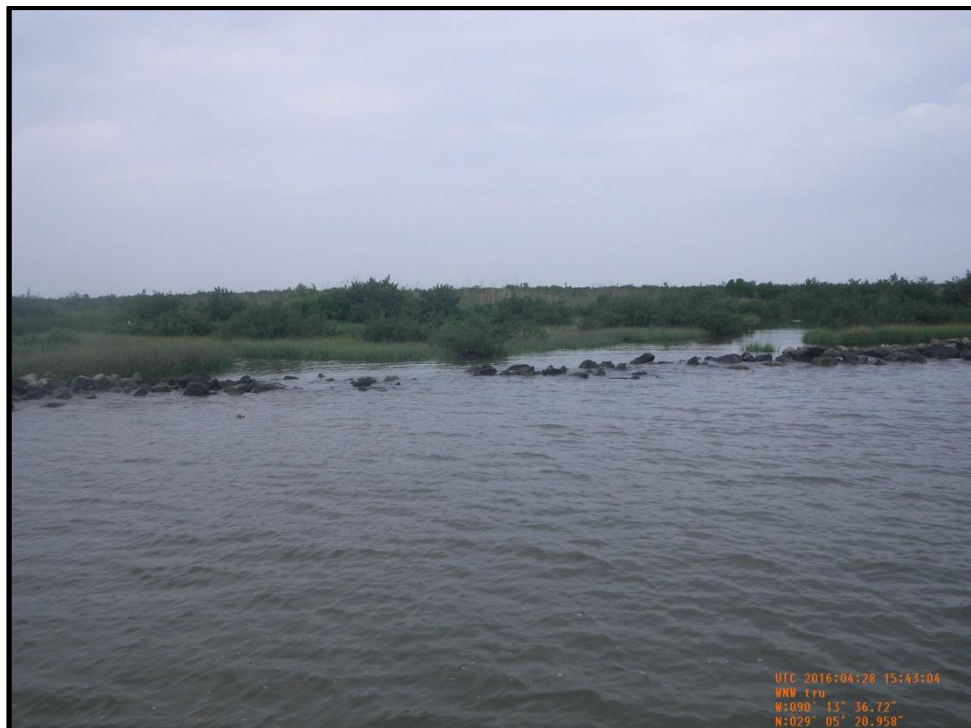
The rock closures, Closures #4 and #5, located in line with the shoreline protection rock along the west bank of Belle Pass are in fair to good condition with no signs of significant settlement. We did notice a slight displacement of the riprap along Closure #4 which appeared in photos taken during previous inspections. Although there is slight displacement of the rock material, the structure seems to be in stable condition with no obvious breaches (Photos 13 - 14, 21 - 22).

**Figure A-2. View of low rock along Closure No. 5.**

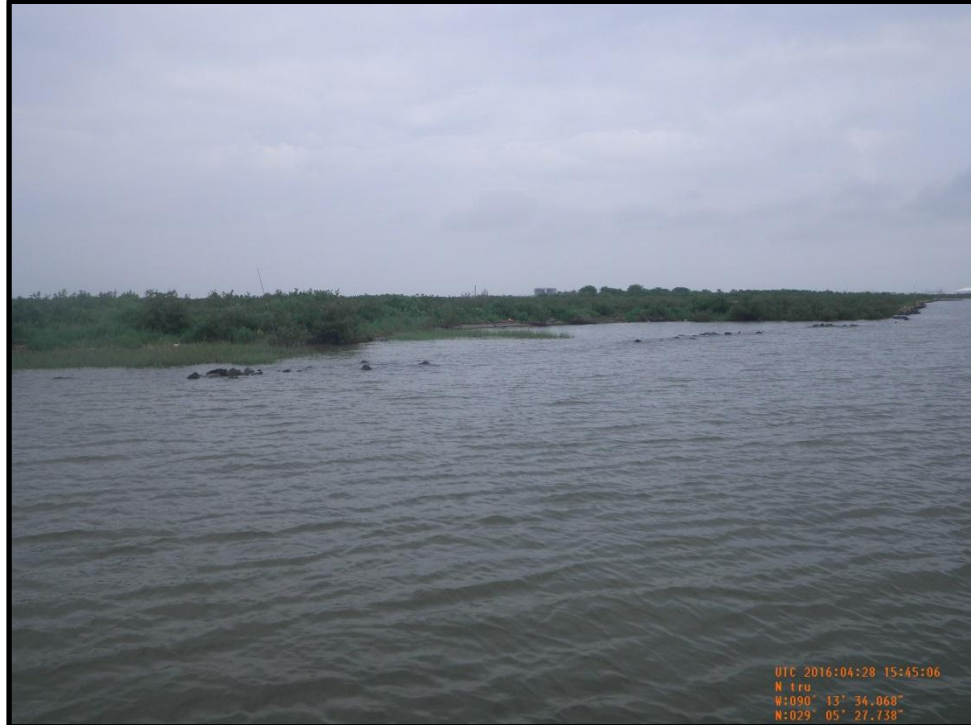
**Figure A-3. View of low rock at the end Closure No. 5.**

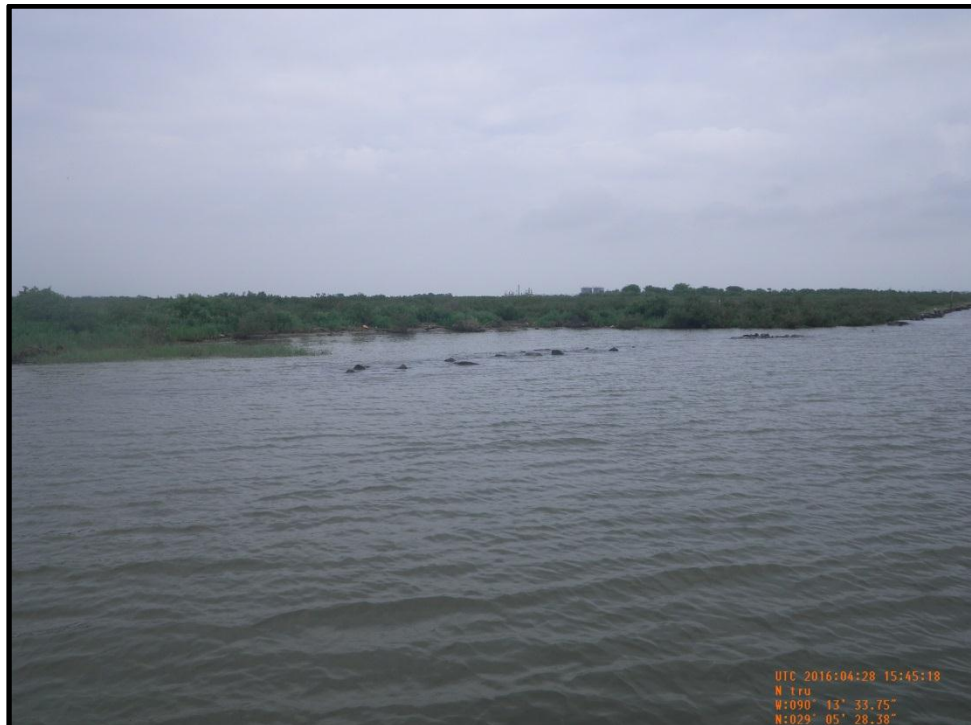
**Figure A-4. View of low rock at the end Closure No. 5.**

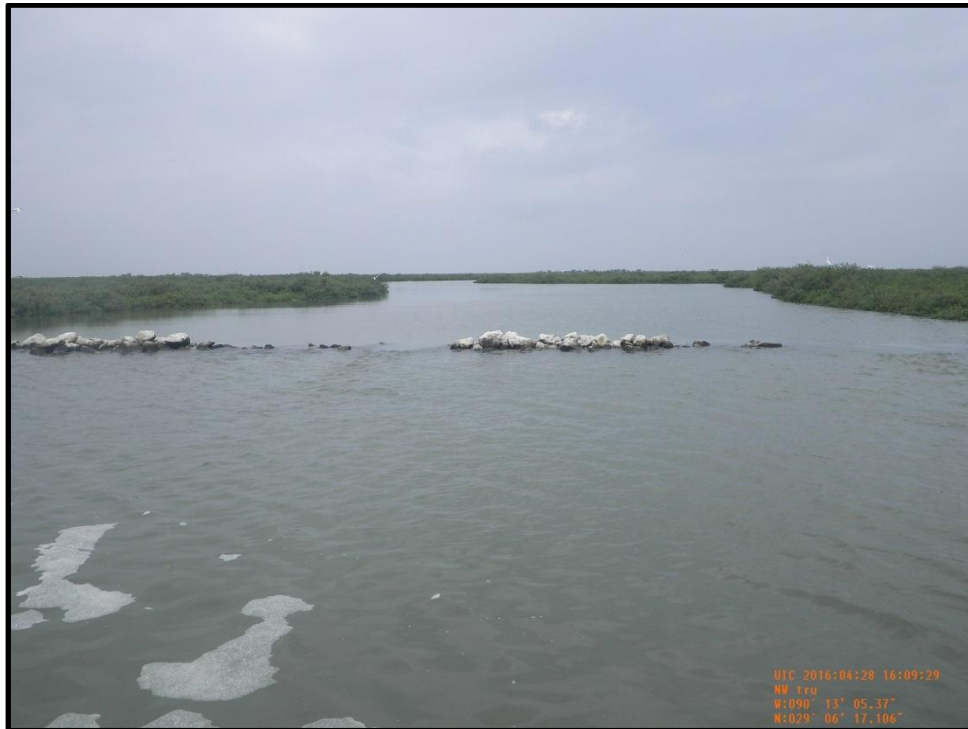
**Figure A-10.** View of the Closure No. 4 rock structure. Note the water flow over damaged segments of the closure.

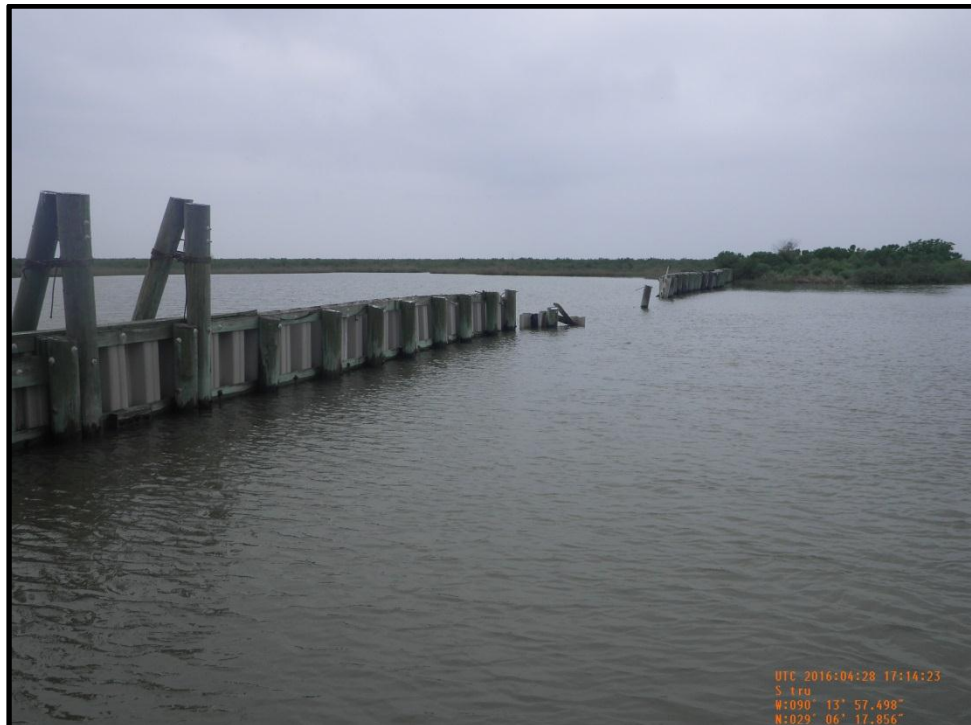
A 2007 maintenance event was undertaken to enhance the TE-23 project and to remove shoaling from the federal channel (Bayou Lafourche and Belle Pass). The completion report (USACE 2007) for this maintenance details the specifics of this event and was applied to write the summation below. During this event, dredged materials were deposited into the marsh creation area and the West Belle Pass beach and closure 1 was re-constructed with sheet pile. While dredging operations were in progress, the sheet pile wall collapsed in the center of closure 1. Because the sheet pile wall buckled, the remaining dredged materials were pumped onto the West Belle Pass Beach. Approximately, 325,855 m<sup>3</sup> (426,202 yd<sup>3</sup>) of dredged material were placed into the closure 1 disposal area and 85,259 m<sup>3</sup> (111,515 yd<sup>3</sup>) were added to the West Belle Pass Beach. A second 2007 maintenance event was initiated to repair damages to the sheet pile wall and install batter piles in the center of closure 1. The repaired sheet pile wall (closure 1) was damaged for a second time by the passage of Hurricanes Gustav and Ike in September 2008. The sheet pile wall has remained in disrepair since that time.

Closure #1 was originally constructed as an earthen closure located along the east bank of the Tennessee Gas Pipeline canal that forms the western boundary of the project area. It was constructed in line with the east bank of the pipeline canal. All of the original earthen Closure #1 had breached and eroded due to tidal exchange between Timbalier Bay and the project wetland restoration area. In order to facilitate the placement of the maintenance dredged material in 2007, this closure was reconstructed as a vinyl sheetpile wall. In 2008, Closure #1 was breached as a result of the tidal surge associated with Hurricane Ike. The width of the breach is approximately 75 feet. The water depth at the breach was sounded and recorded at approximately 18 feet indicating a deep scour from tidal exchange through the breach. Other damage along the length of the bulkhead was noted as well, including bolt pullout, timber whaler damage, and localized sheetpile deflection in some areas. The 2016 inspection revealed similar conditions noted in 2013, following Hurricane Ike. Although the vinyl bulkhead is damaged, it doesn't appear to be a detriment to the project since the remaining marsh behind the structure seems to be stable at this time. Therefore, we are not recommending replacement of Closure #1 and will continue to monitor the condition of the vinyl bulkhead and interior marsh on future site visits (Photos 1 – 5).

**Figure A-14. Damaged Closure No. 1 sheet pile wall used as containment during the 2007 maintenance event.**

Amongst project features, the only noticeable damage is contributed to the sheet pile wall. The original function and need of the sheet pile wall was to serve as containment during pumping; after construction, the feature coincidentally served as a water control structure. Regardless of damage, the original purpose has been served and there will be no further recommendations to repair the structure or alter other project features.

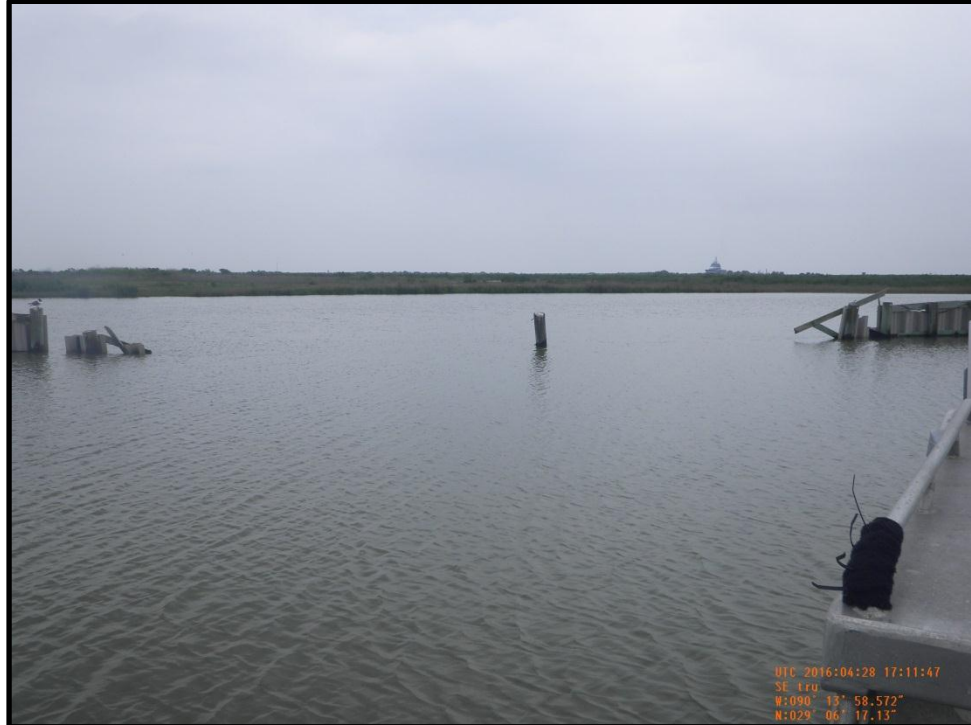
**Figure A-15. View of the large breach in the Closure No. 1 sheet pile wall.**

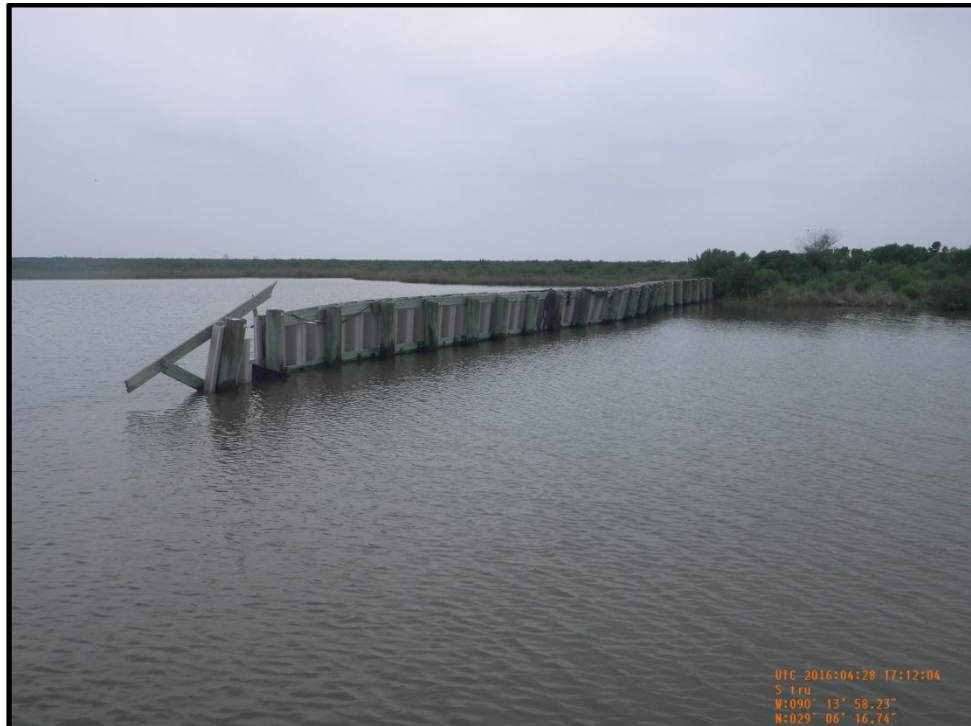
**Figure A-16. View of the southern extent of the breached Closure No. 1 sheet pile wall.**

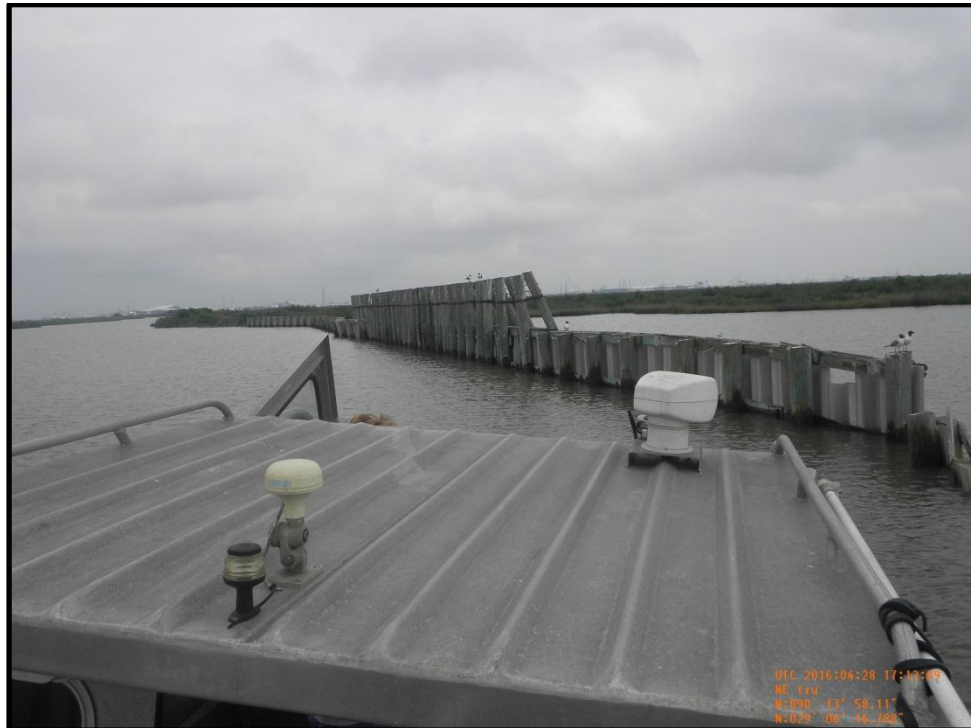
**Figure A-17. View of the northern extent of the breached Closure No. 1 sheet pile wall. Note batter piles were only placed across a quarter length segment of the closure structure.**
